AFWAL-TR-83-4039

RAIN EROSION MECHANISMS OF  
FLUOROELASTOMER AND POLYURETHANE  
COATINGS ON SELECTED COMPOSITE  
SUBSTRATES

APRIL 1983

Special Interim Report for the Period July 1980 - February 1983

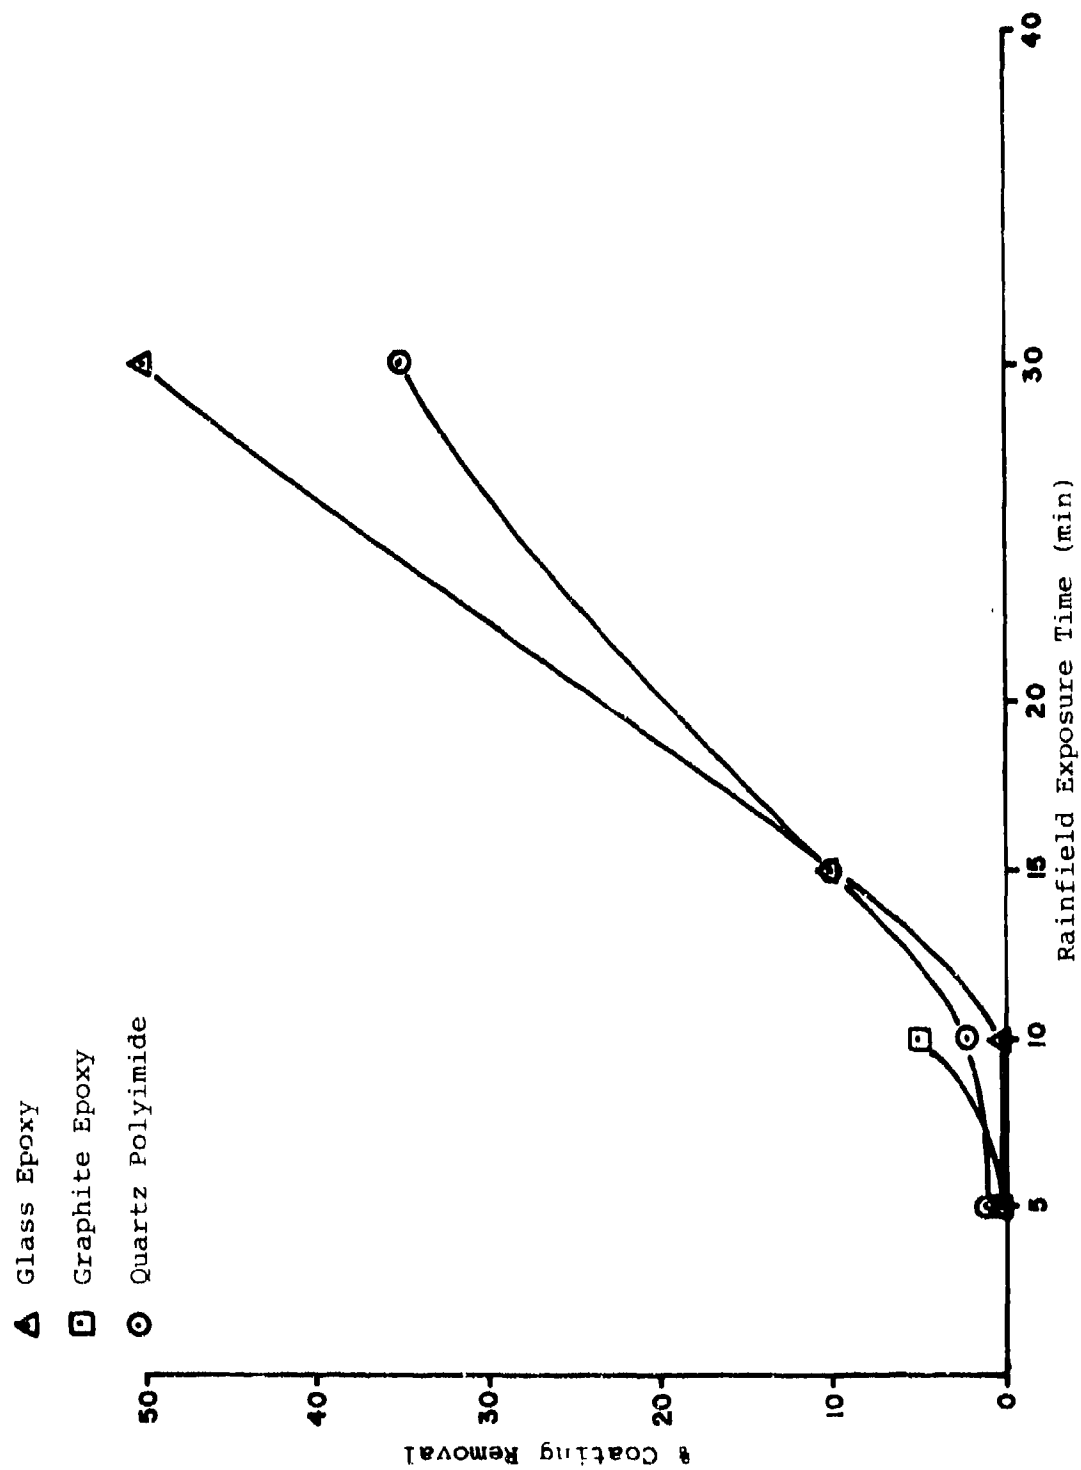
Figure 4. Fluoroelastomer Coating - % Coating Removal vs. Exposure Time, 90°.

Visual examination, under a lighted magnifier, of the fluoroelastomer coated glass epoxy substrates exhibited initiation of pitting on the exposed edges of coated specimens during the first five-minute interval of rainfield exposure. At the ten-minute interval of rainfield exposure, surface pitting and several areas of very localized adhesion loss were observed at the exposed edges of the coated specimens. Continued rainfield exposure resulted in increased pitting with 10% coating removal and increasing adhesion loss at the 15-minute interval. Thirty minutes of rainfield exposure resulted in 50% coating removal with additional adhesion loss and erosion of the glass epoxy substrate. Percent coating loss as a function of rainfield exposure time is shown in Figure 4.

The fluoroelastomer coated graphite epoxy specimens exhibited no visible surface damage after five minutes of rainfield exposure. At the 10-minute interval of rainfield exposure, however, coating losses averaged 5% of the coated surface area and up to 50% adhesion loss of the fluoroelastomer from the graphite epoxy substrate. Percent coating loss versus rainfield exposure time is shown in Figure 4.

Five minutes of rainfield exposure of the fluoroelastomer coated quartz polyimide substrate resulted in the initiation of pitting and 1% coating removal. Ten-minute exposures exhibited increased pitting, approximately 2% coating removal,

and partial adhesion loss of the fluoroelastomer coating to the substrate. Continued pitting, 10% coating loss and partial adhesion loss occurred at the 15-minute interval of rainfield exposure. Thirty-minute exposures exhibited 35% coating loss, partial coating adhesion loss, and severe erosion of the exposed quartz polyimide substrate. Results are shown in Figure 4.

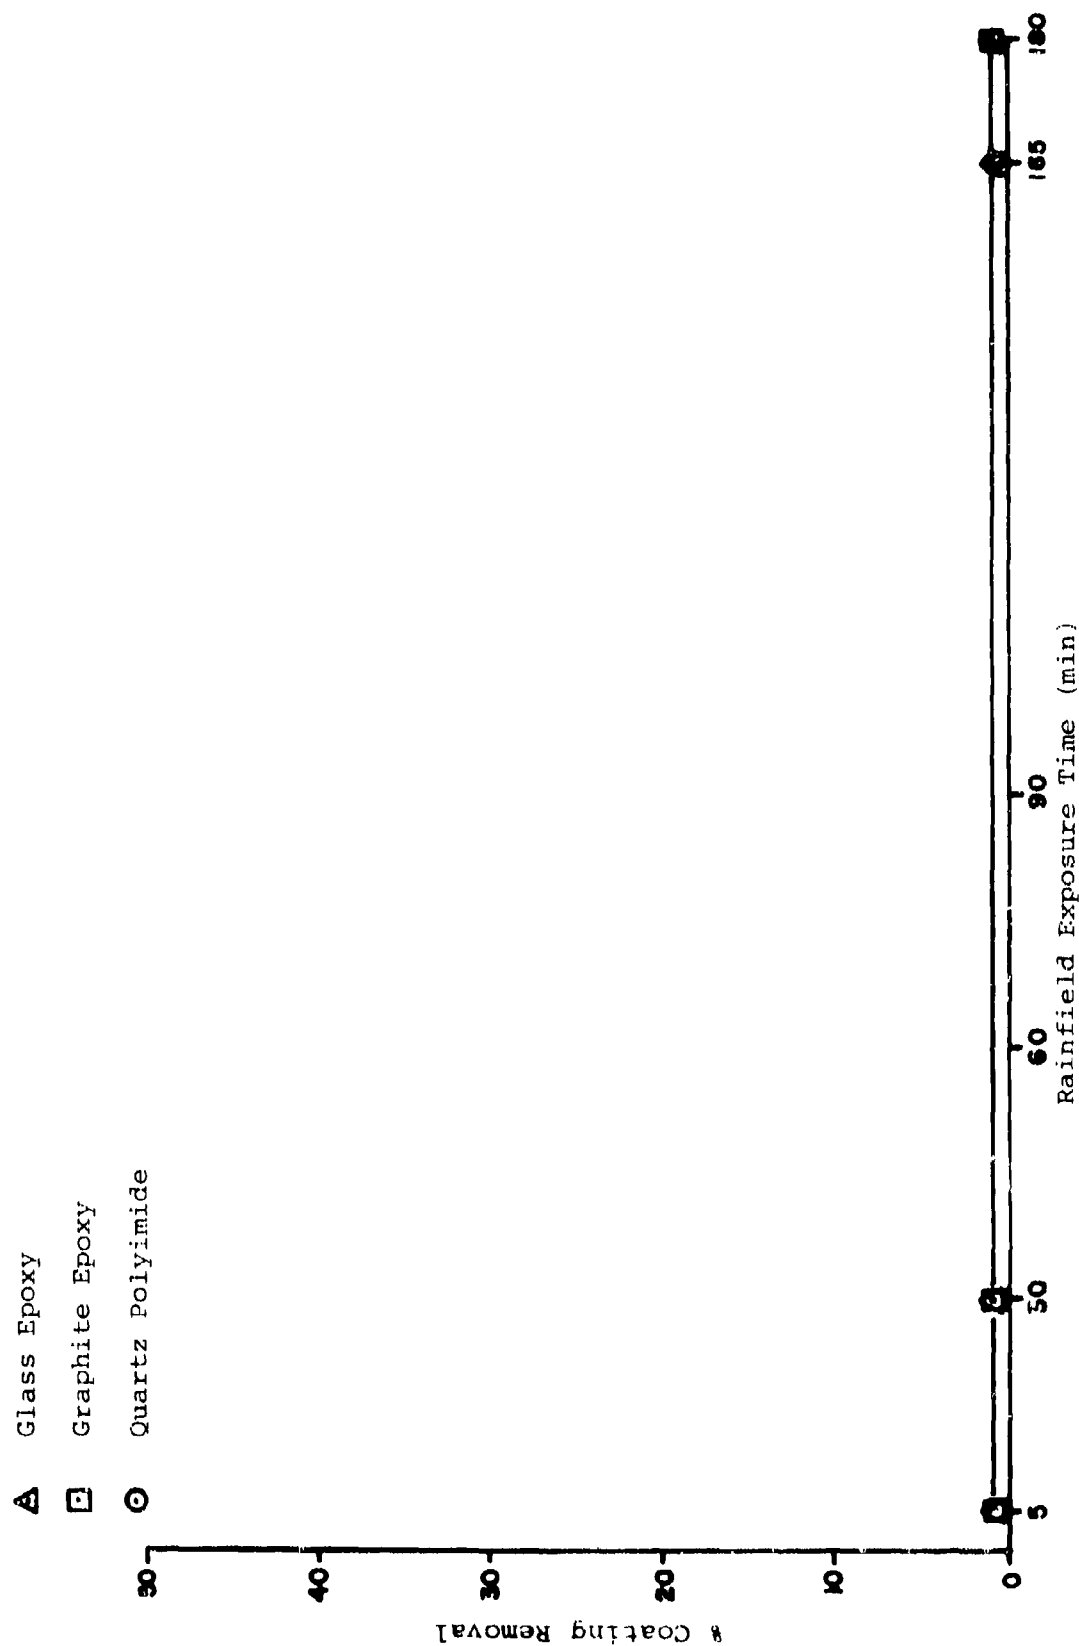
Figure 5. Fluoroelastomer Coating - % Coating Removal vs. Exposure Time, 30°.

Examination of the fluoroelastomer coated glass epoxy substrates exposed to a five-minute interval of rainfield exposure resulted in no visible damage. Thirty-minute rainfield exposures visually indicated pitting initiation and no measurable coating loss. Increased pitting, partial coating adhesion loss and composite substrate damage occurred after 165 minutes of rainfield exposure at 500 mph. Results are shown in Figure 5.

Five-minute rainfield exposure of the fluoroelastomer coated graphite epoxy substrate resulted in no visible damage. Thirty-minute exposure resulted in partial coating adhesion loss and composite damage. Exposure to 180 minutes of rainfield exposure showed partial adhesion loss and increased composite substrate damage. The results are shown in Figure 5.

Visual examination of the fluoroelastomer coated quartz polyimide substrate after five minutes of rainfield exposure indicated no visible damage. Exposure to thirty minutes of the rainfield environment also resulted in no visible damage. Further exposure to 180 minutes of the simulated rainfall produced pitting, partial coating edge delamination, and composite damage. The results are shown in Figure 5.

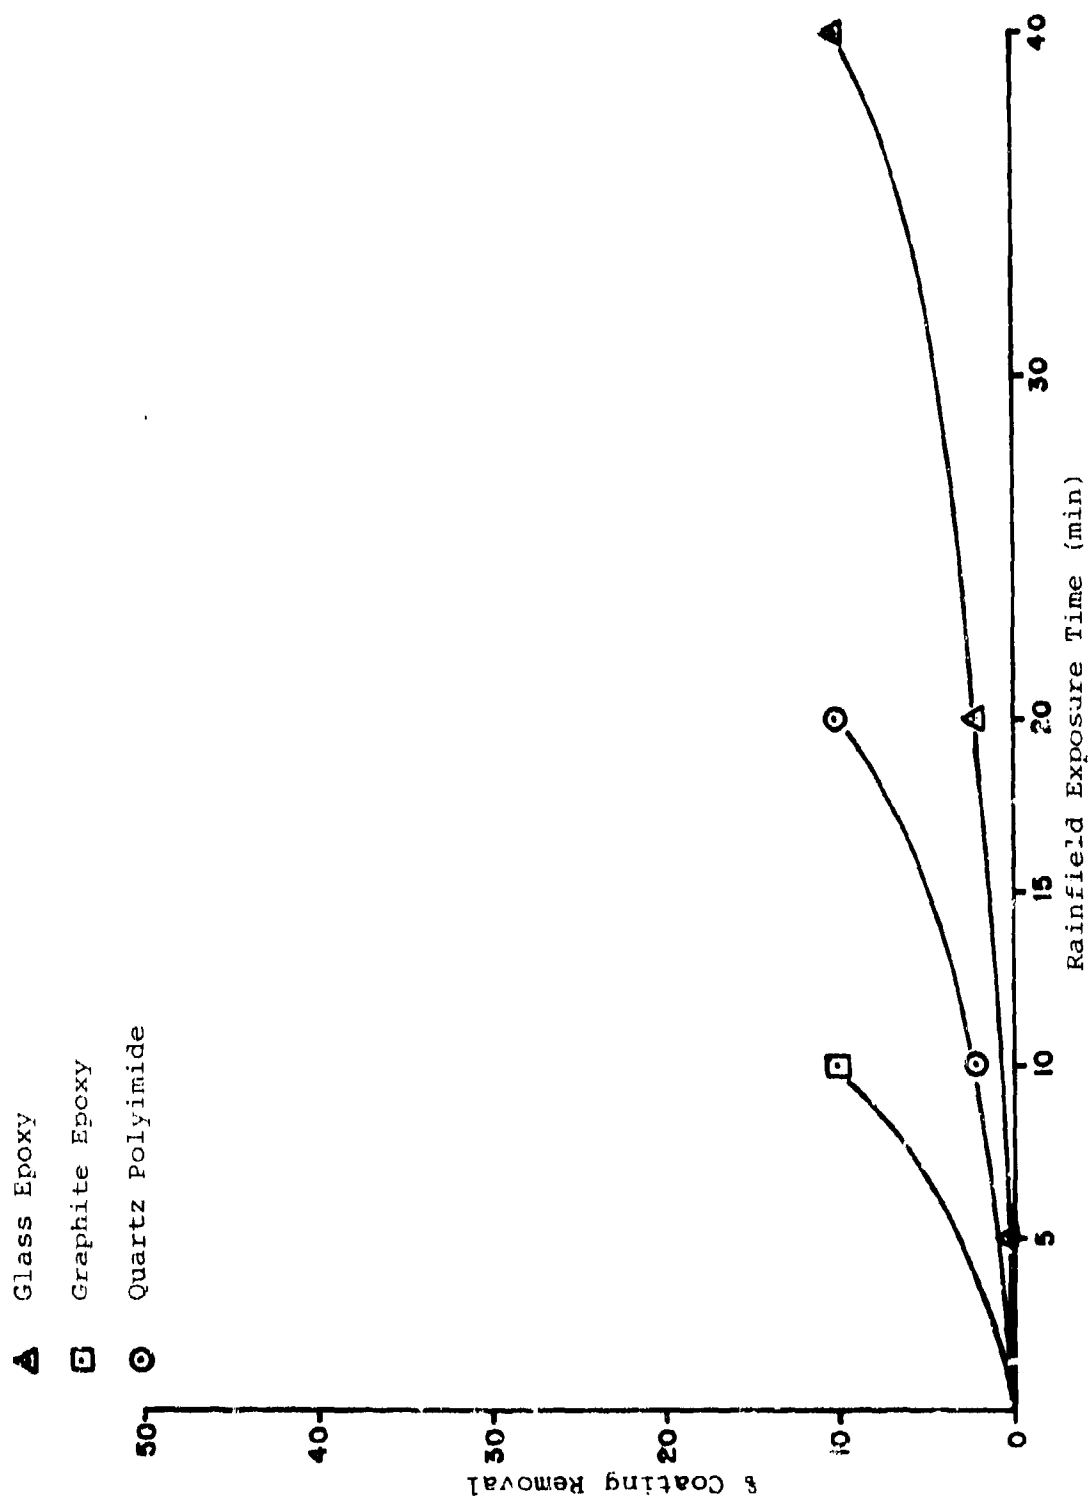
Figure 6. Polyurethane Coating - % Coating Removal vs. Exposure Time, 90°.

Visual examination, under a lighted magnifier, of the polyurethane coated glass epoxy substrate revealed no visible damage after five minutes of rainfield exposure. At the 10-minute interval of rainfield exposure, 2% of the coating was removed with partial coating adhesion loss at the edges of the specimens. Continued rainfield exposure resulted in slight pitting, no increase in coating removal, and increased adhesion loss at the coating edges at the 20-minute exposure interval. Forty minutes of rainfield exposure exhibited 10% coating removal and increased coating adhesion loss. Results are shown in Figure 6.

The polyurethane coated graphite epoxy specimens exhibited no visible surface damage after five minutes of rainfield exposure. At the 10-minute interval, coating removal losses averaged 10% of the coated surface area and up to 60% coating adhesion loss of the polyurethane from the graphite epoxy substrates. Percent coating loss versus rainfield exposure time is shown in Figure 6.

Five minutes of rainfield exposure of the polyurethane coated quartz polyimide substrates resulted in partial coating adhesion loss at the specimen edges. Ten-minute exposures exhibited increased coating adhesion loss of the polyurethane from the quartz polyimide specimens and 2% coating removal. Further rainfield exposures totaling 20 minutes produced 10% coating loss and increasing coating adhesion losses. Results are shown in Figure 6.

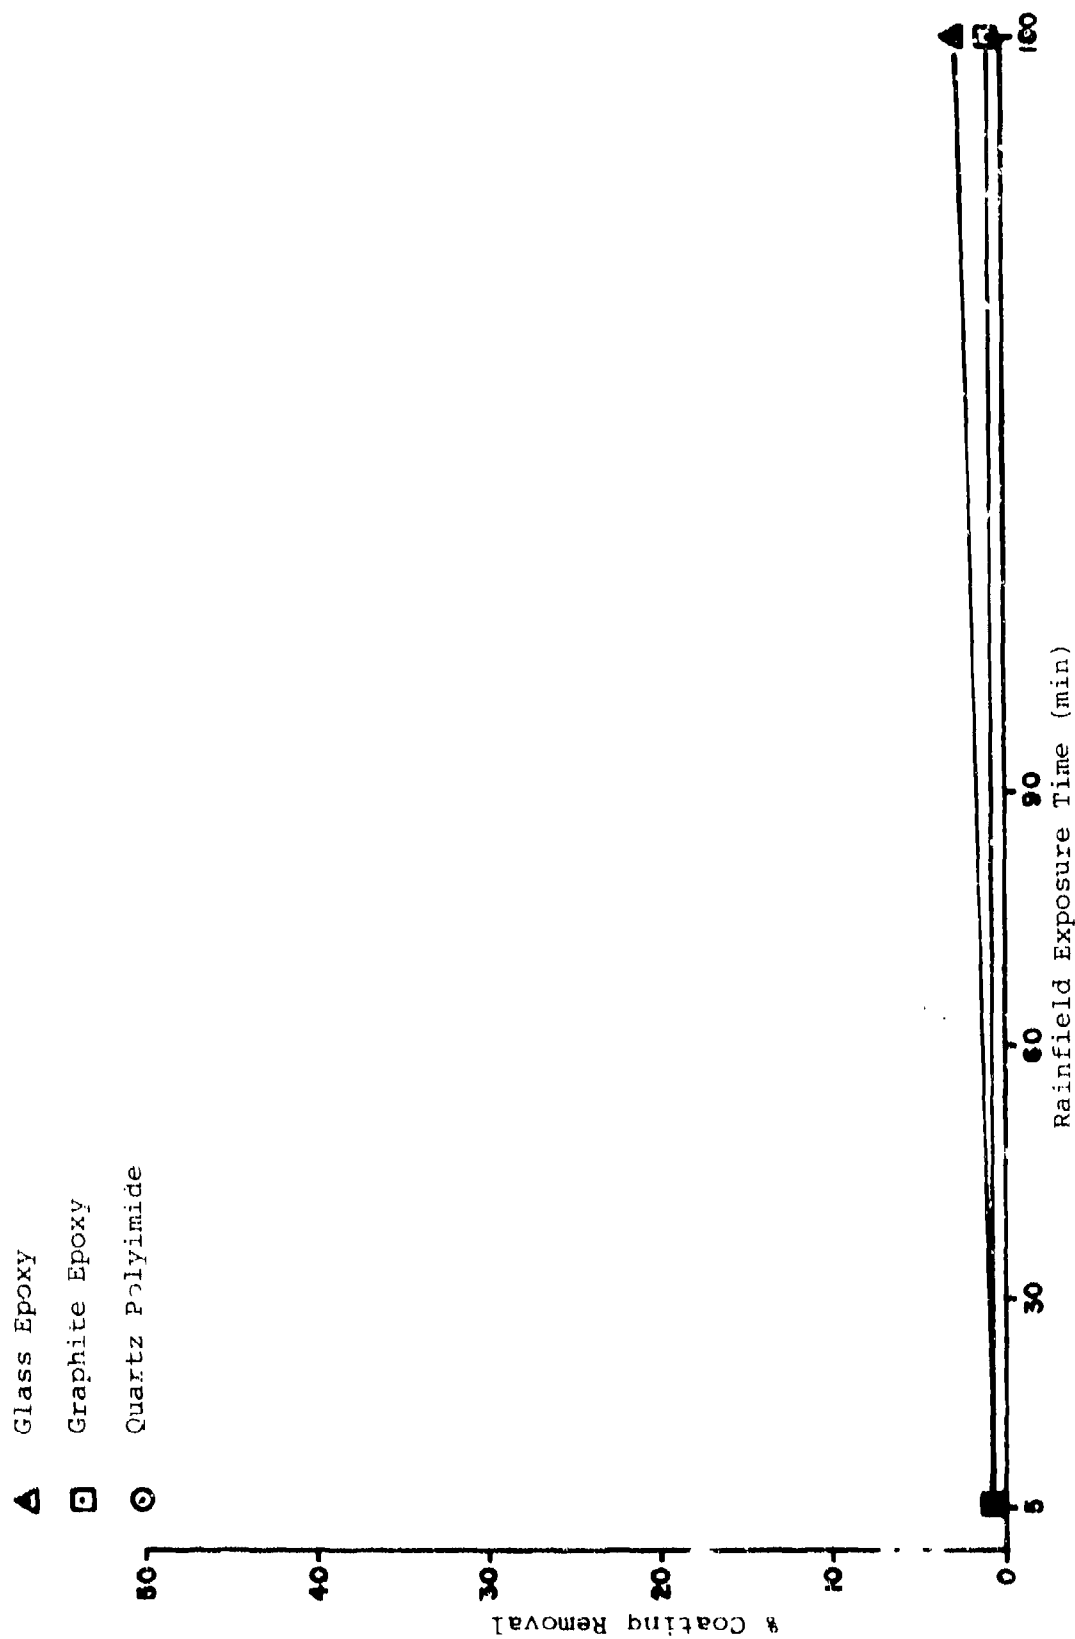
Figure 7. Polyurethane Coating - % Coating Removal vs. Exposure Time, 30°.

damage. Exposures to 180 minutes of the rainfield environment resulted in 3% coating removal and partial coating delamination from the glass epoxy substrates. Percent coating removal versus rainfield exposure time is shown in Figure 7.

Exposures of five minutes and 30 minutes to rainfield exposure conditions resulted in no visible damage of the polyurethane coated graphite epoxy specimens. One hundred and eighty minutes of exposure produced partial coating adhesion losses and substantial damage to the graphite epoxy composites. Results are shown in Figure 7.

No visible damage was observed after five minutes and 30 minutes exposure to rainfield conditions for the polyurethane coated quartz polyimide specimens. One hundred and eighty minutes of exposure produced slight coating adhesion loss and very slight damage to the quartz polyimide substrates. Results are shown in Figure 7.

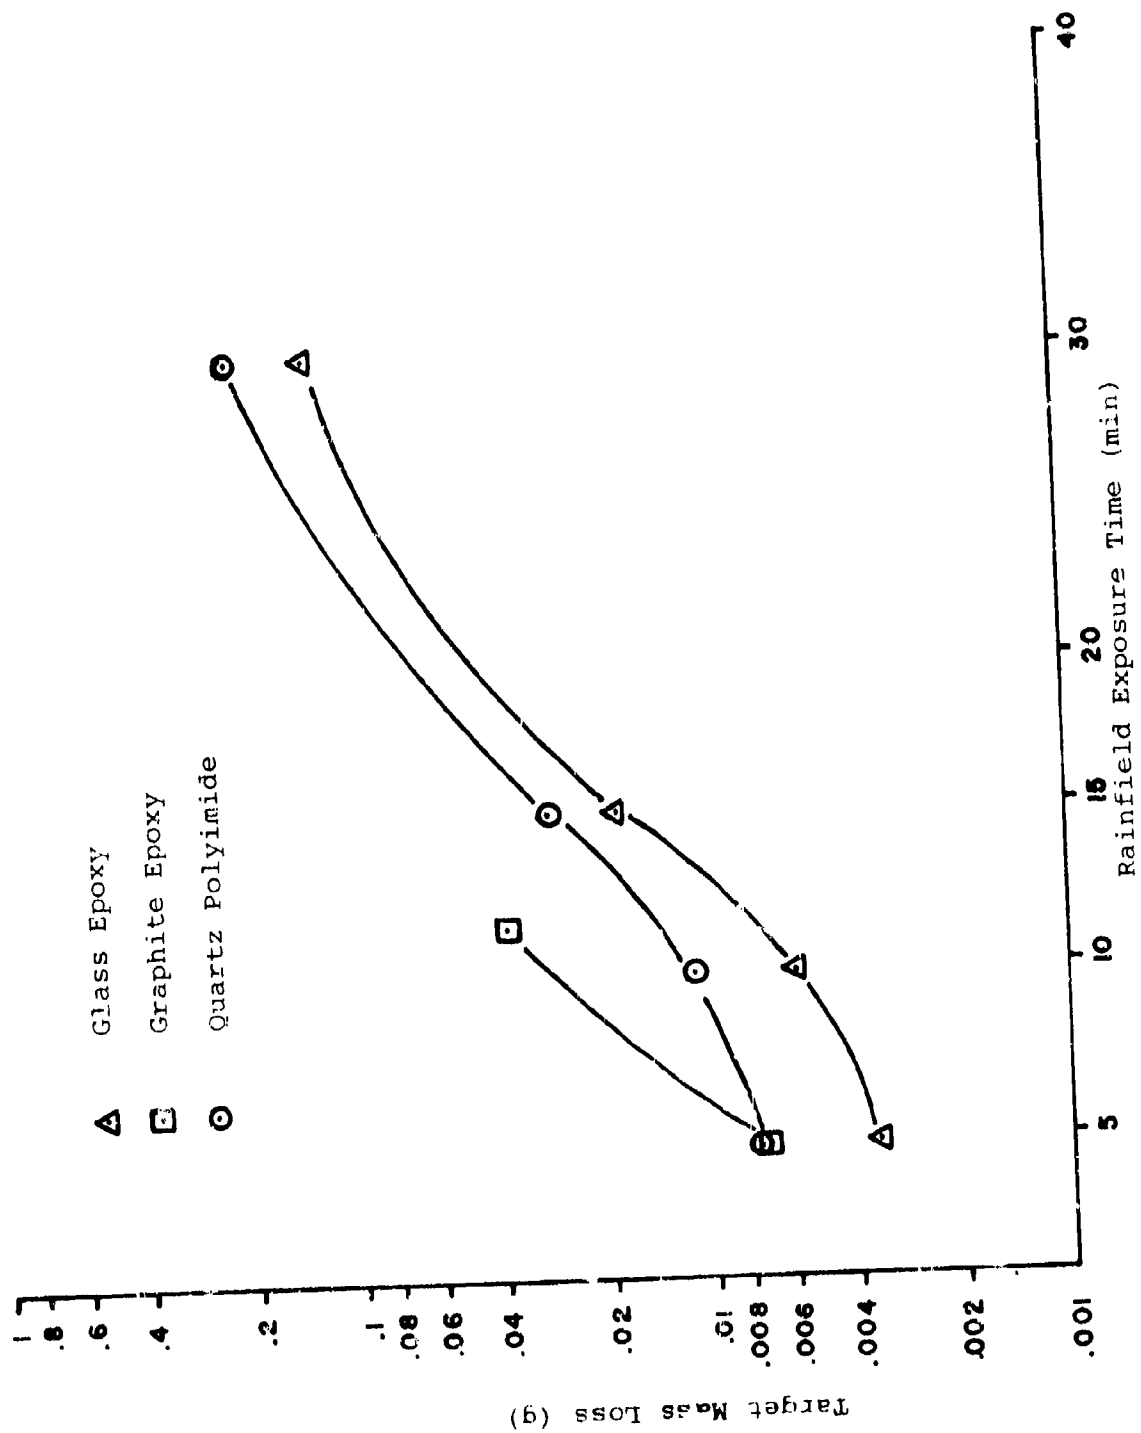
Figure 8. Target Mass Loss of Fluoroelastomer Coated Composites Exposed at a 90° Impact Angle, 500 mph, 1 inch/hr Rainfall.

mass loss of 0.0076 g. An order of magnitude increase in target mass loss occurred at 10 minutes of rainfield exposure. Mass loss at this interval resulted in a 0.039 g weight loss.

Figure 8 shows a comparison of target mass loss for the fluoroelastomer/composite combinations exposed at a 90° impact angle and a velocity of 500 miles per hour.

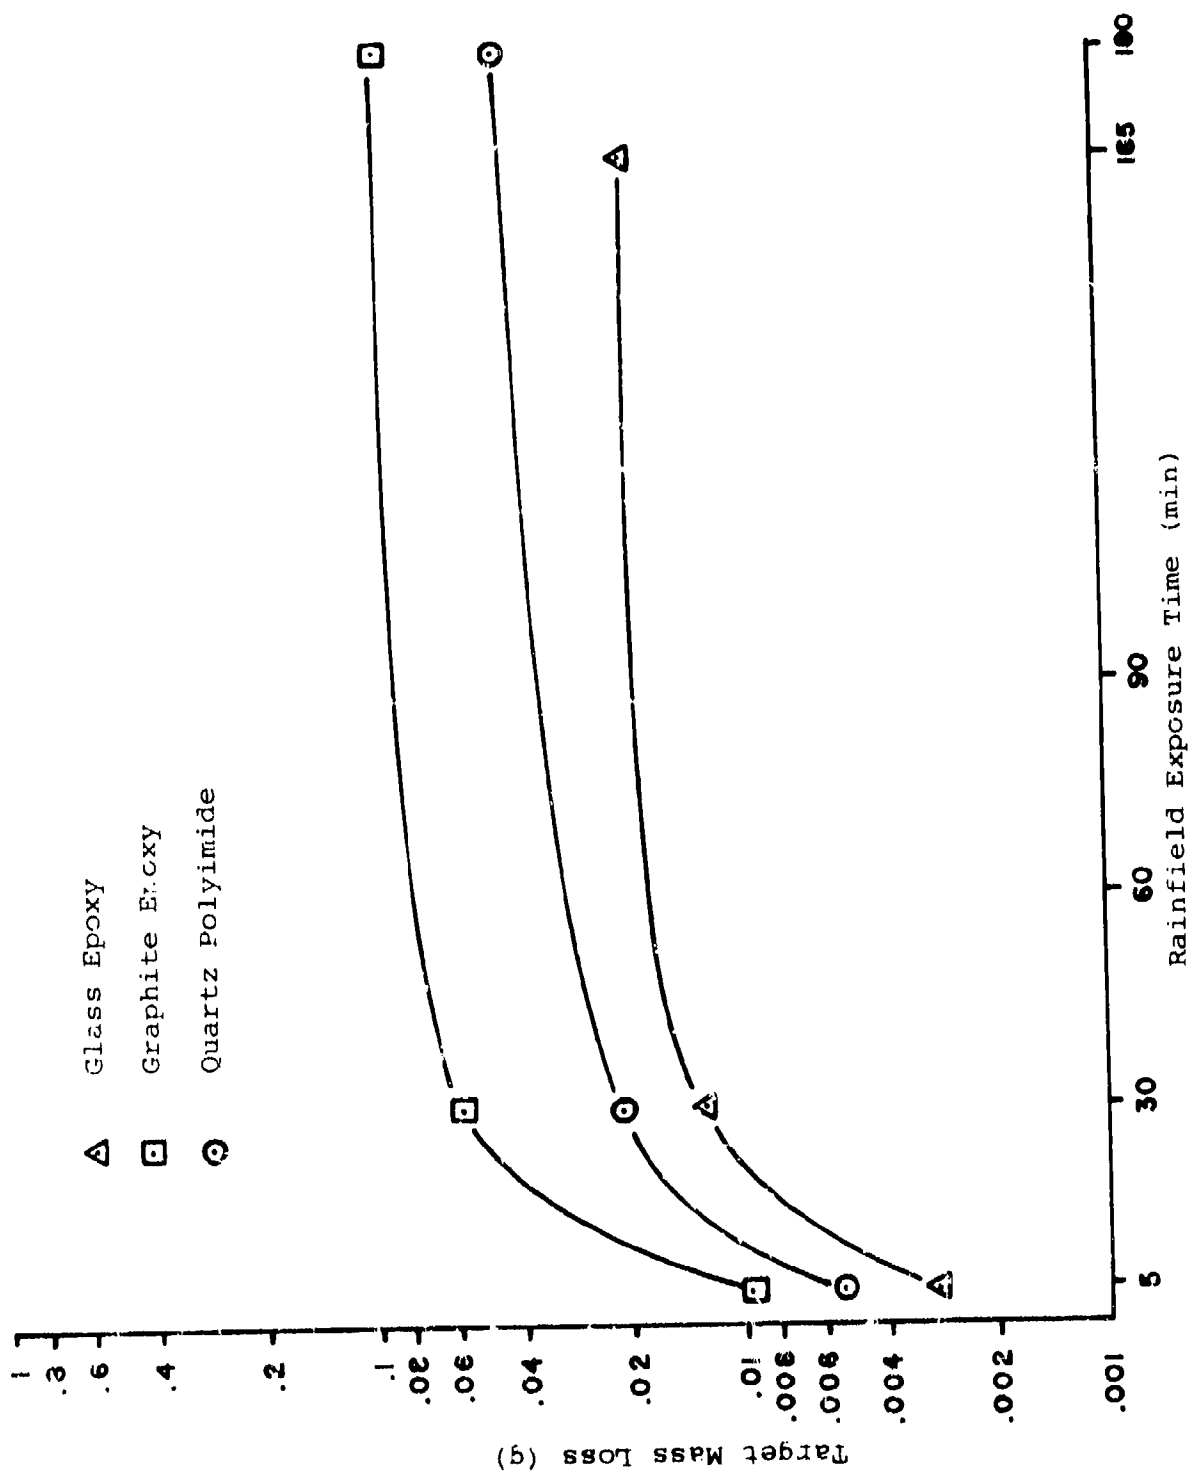
Figure 9. Target Mass Loss of Fluoroelastomer Coated Composites Exposed at a 30° Impact Angle, 500 mph, 1 inch/hr Rainfall.

Five-minute rainfield exposure of the fluoroelastomer coated graphite epoxy substrates resulted in an average mass loss of 0.0097 g. An order of magnitude change in target mass loss occurred at the 30-minute exposure interval. The average weight loss was 0.0616 g. A minimal increase in mass loss occurred after 180 minutes of rainfield exposure. Average target mass loss totaled 0.0960 g.

Figure 9 shows a comparison of target mass loss for the fluoroelastomer/composite combinations at a 30° impact angle and a velocity of 500 miles per hour.

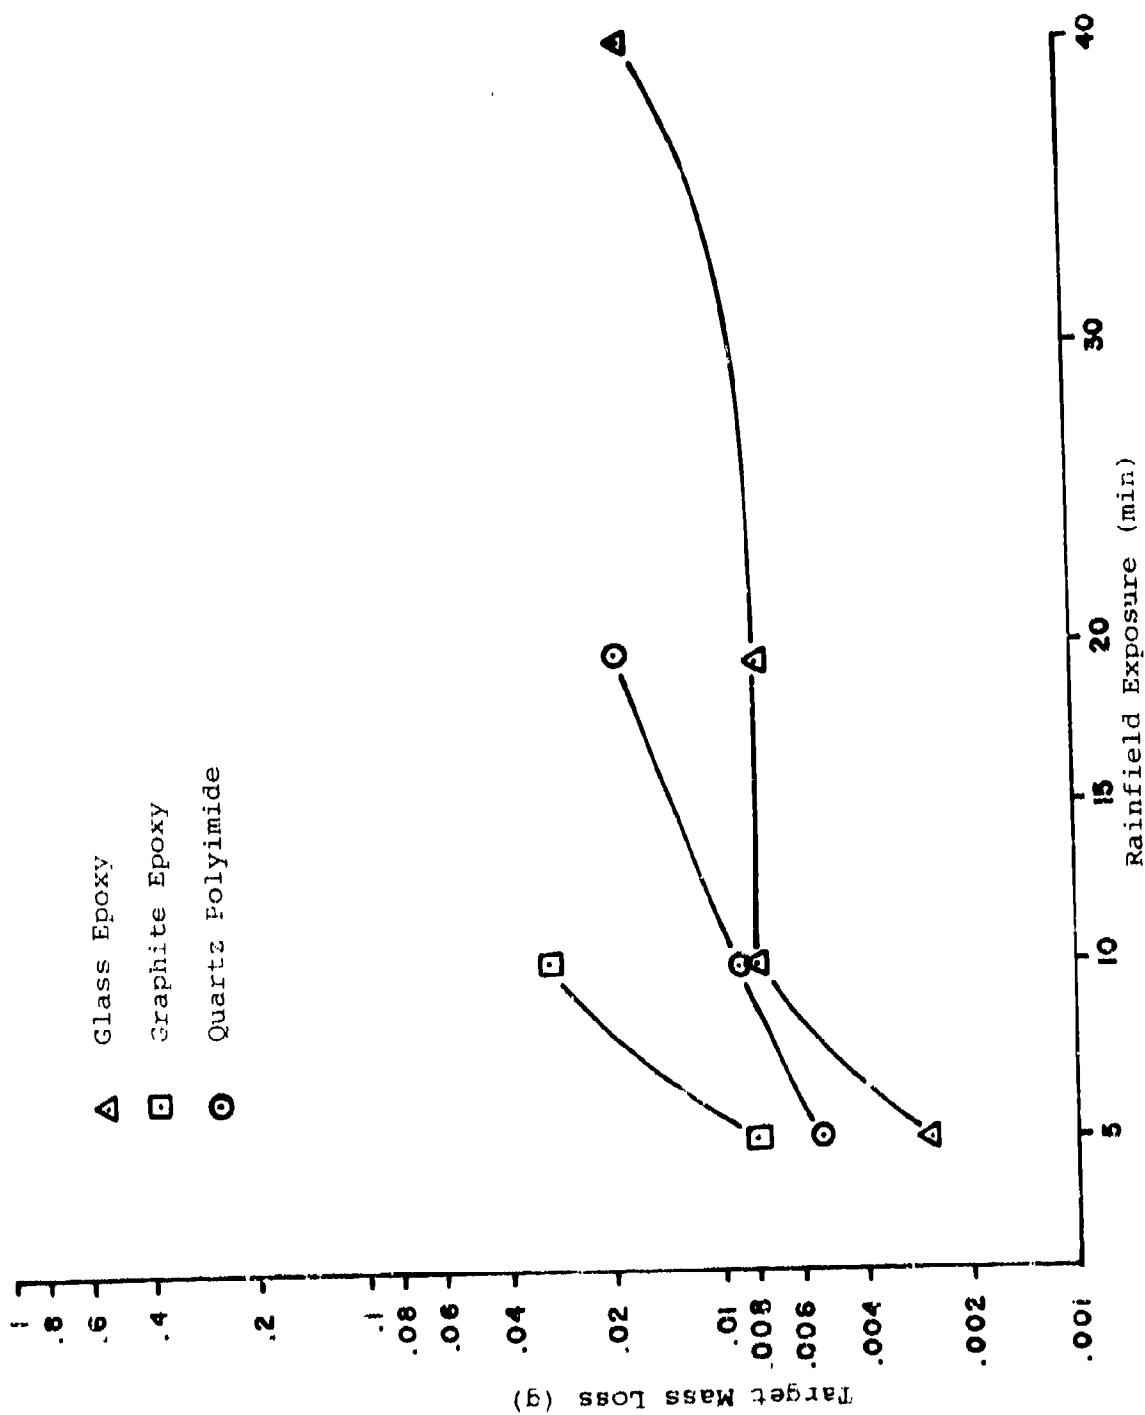
Figure 10. Target Mass Loss of Polyurethane Coated Composites Exposed at a 90° Impact Angle, 500 mph, 1 inch/hr Rainfall.

Rainfield exposure of five minute duration with polyurethane coated graphite epoxy specimens resulted in an average mass loss of 0.0080 g. Exposure to 10 minutes of rainfield conditions produced an order of magnitude increase in target mass loss for these materials. Total average mass loss at 10 minutes was 0.0301 g.

Five-minute rainfield exposure of the polyurethane coated quartz polyimide substrates resulted in an average mass loss of 0.0052 g. An average mass loss of 0.0088 g occurred after 10 minutes of exposure for this coating/substrate combination. Twenty-minute rainfield exposure produced an average total target mass loss of 0.0188 g.

Figure 10 shows a comparison of target mass loss for the polyurethane/composite combinations exposed at a 90° impact angle and a velocity of 500 miles per hour.

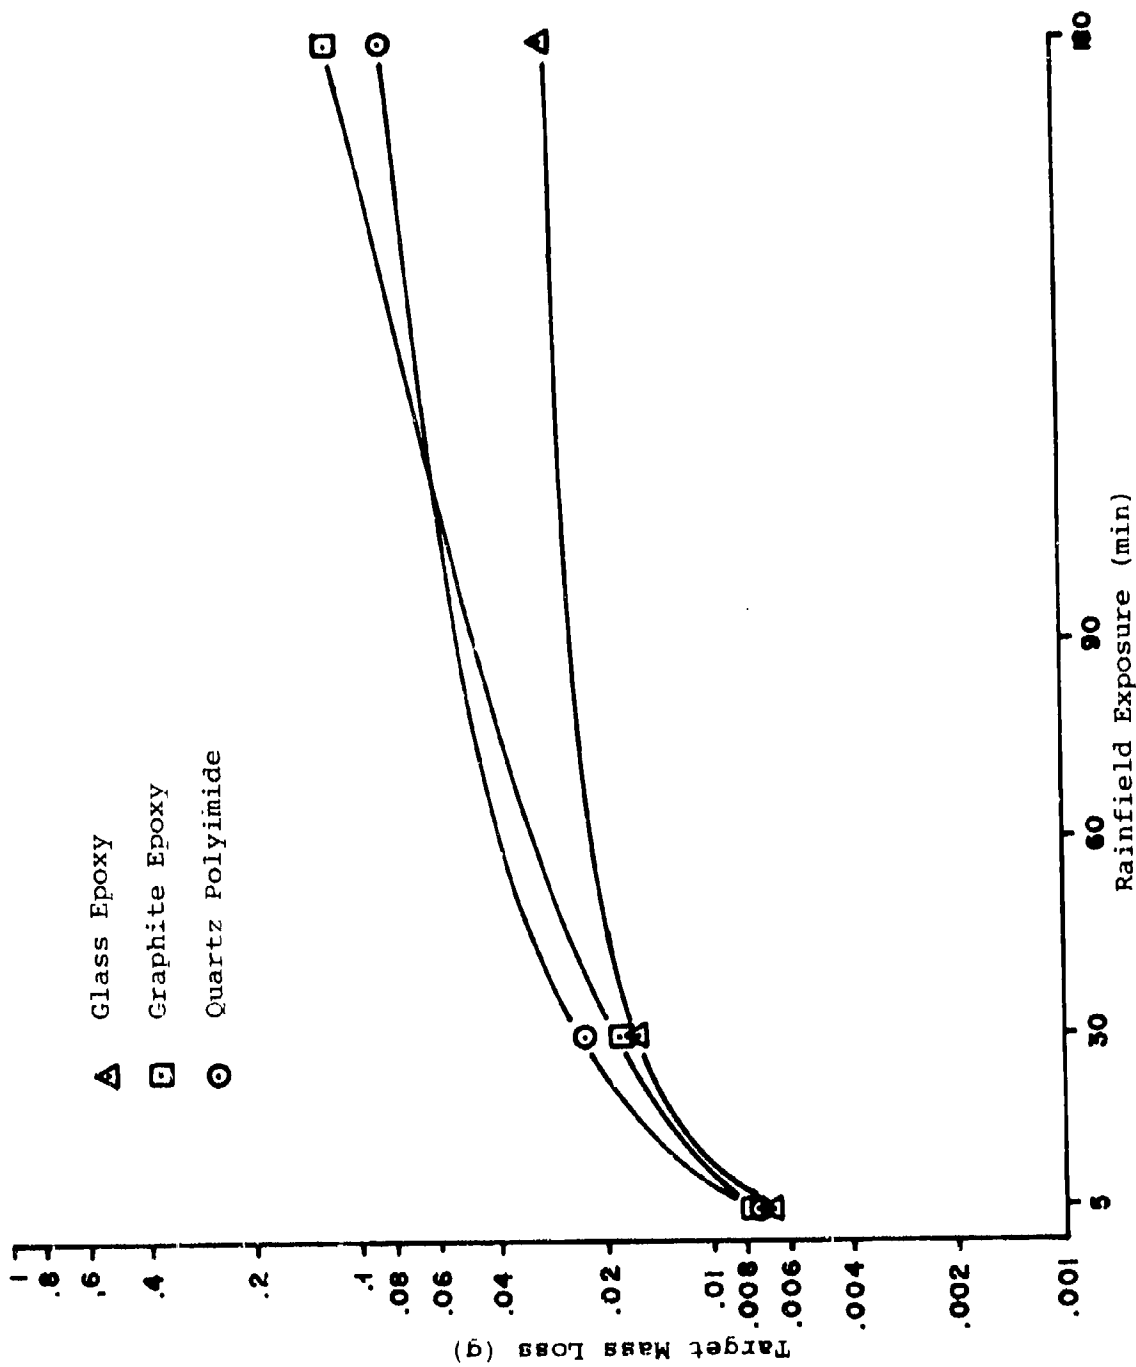
Figure 11. Target Mass Loss of Polyurethane Coated Composites Exposed at a 30° Impact Angle, 500 mph, 1 inch/hr Rainfall.

Five-minute rainfield exposure of the polyurethane coated quartz polyimide substrates resulted in an average mass loss of 0.0074 g. An average mass loss of 0.0244 g occurred after 30 minutes of rainfield exposure. One hundred and eighty minutes of exposure produced an average total mass loss of 0.0718 g.

Figure 11 compares the target mass loss of the polyurethane/composite combinations at a 30° impact angle and a velocity of 500 miles per hour.

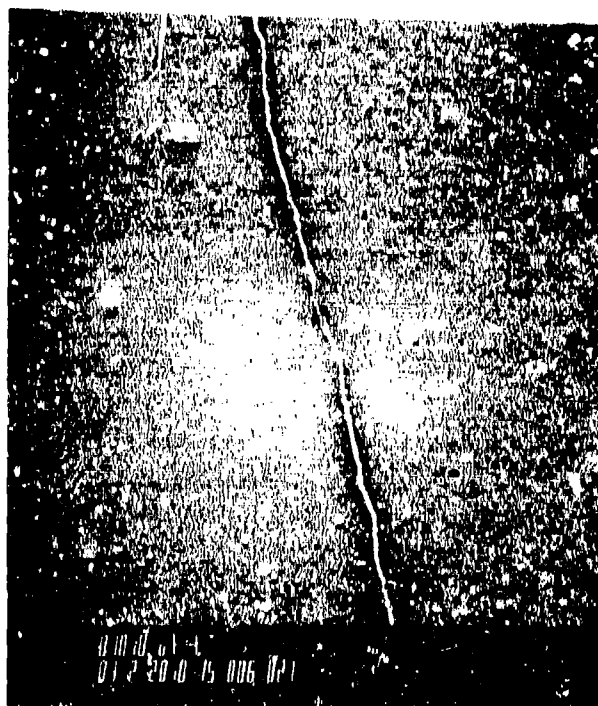
Figure 16. Fluorocastomer Coated Graphite Epoxy Composite.

The fluoroelastomer coated graphite epoxy composite substrate exposure to rainfield conditions is shown in Figure 16. The coating contains a uniform surface morphology with homogeneous distribution of titanium dioxide pigment in the size range of 0.5 microns. This description is exhibited in Figure 16A. It also contained elongated striation defects as shown in Figure 16B.

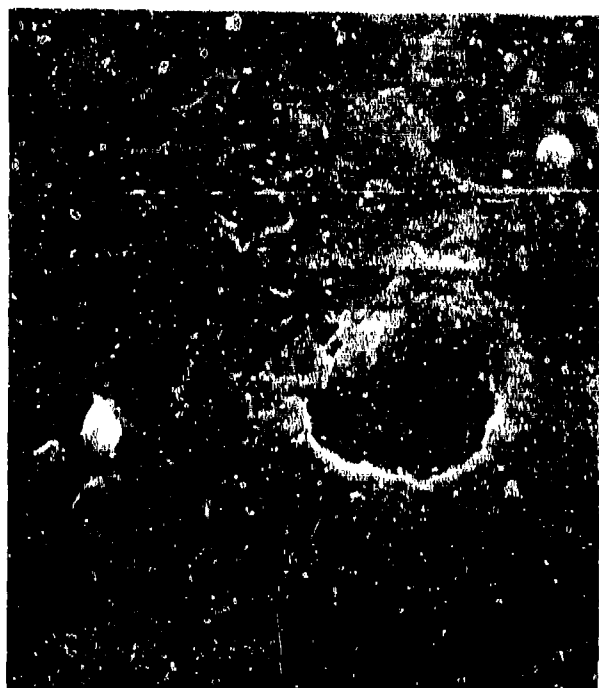
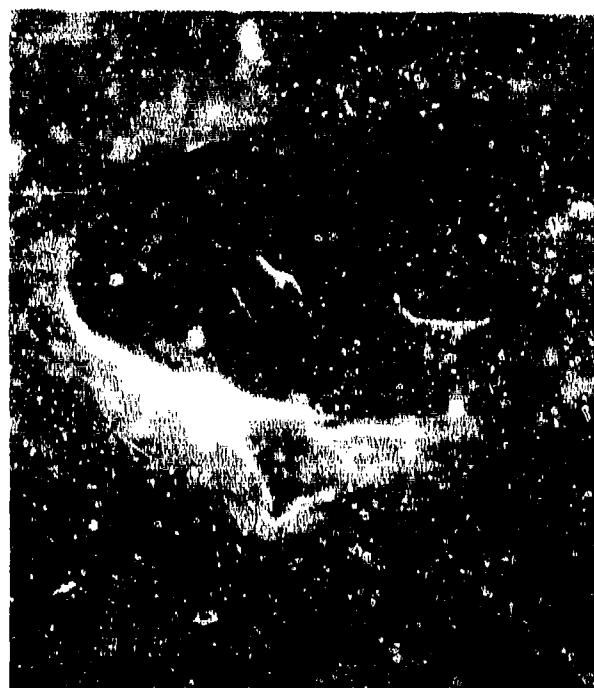
Figure 24. Fluoroelastomer Coated Quartz Polyimide Composite,  
30° Impact Angle.

Scanning electron microscopy observations of fluoroelastomer coated quartz polyimide substrate materials exposed at a 30° impact angle to rainfield conditions for five minutes to 180 minutes revealed surface erosion damage as shown in Figure 24. The erosion damage was characterized by localized coating removal at erosion sites resulting in crater formation. These local events up to 10 microns in size were either isolated as shown in Figure 24A or agglomerated as depicted in Figures 24B and 24C.

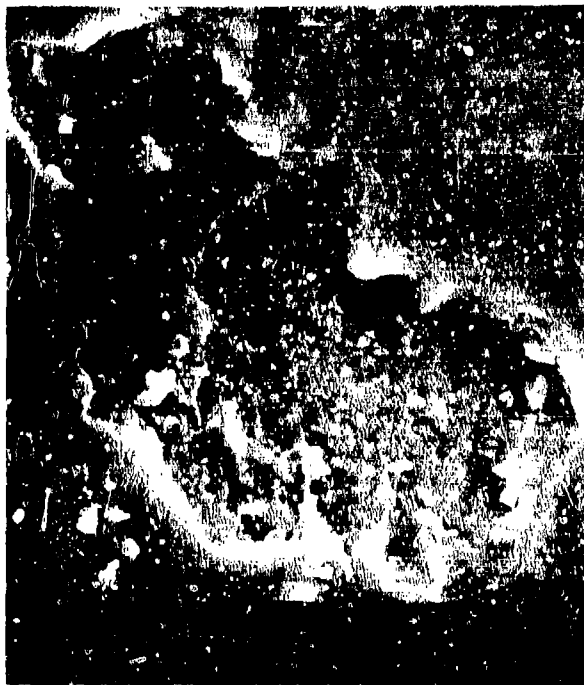
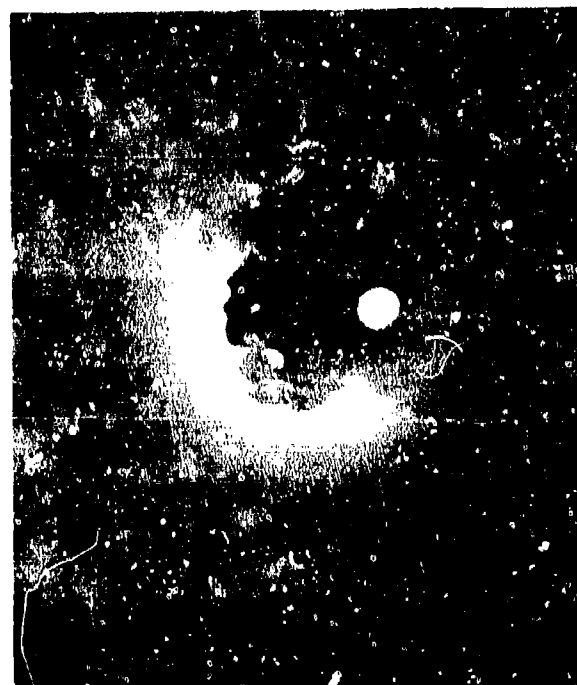
Figure 28. Polyurethane Coated Graphite Epoxy Composite,  
90° Impact Angle.

Erosion damage was introduced into the polyurethane coating surface on the graphite epoxy composite materials during rainfield exposure at a 90° impact angle. Five-minute exposures to rainfield conditions resulted in single craters or clusters of craters as illustrated in Figures 28A and 28B. An exposure to rainfield conditions of 10 minutes duration exhibited extensive microcracking in the polyurethane coating surface and is shown in Figure 28C.
